Isle of Man Marine Administration
Oaseirys Lhuingys

Casualty Investigation Report CA 89

“Mirabella V”

Grounding

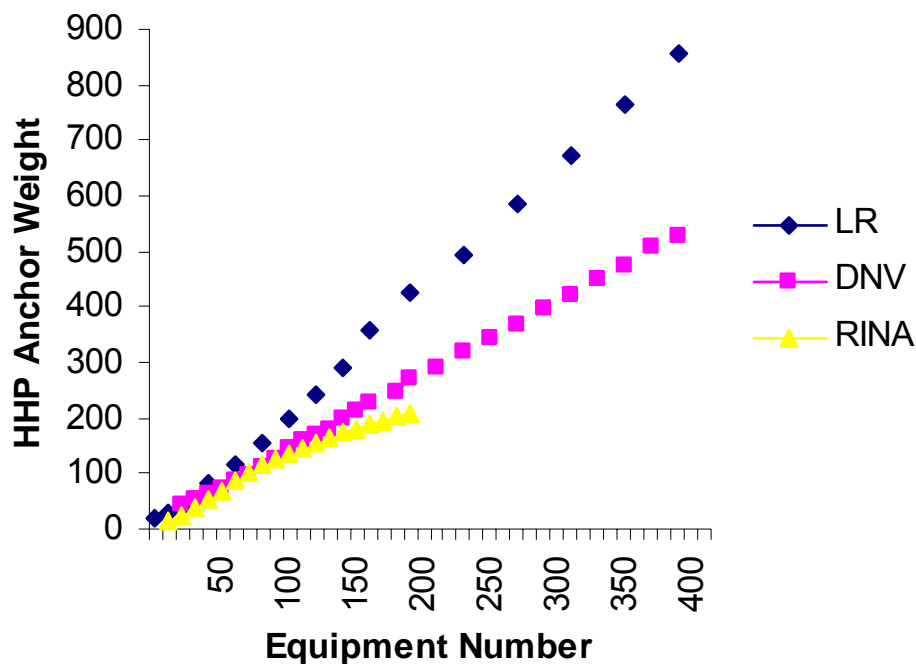
Figure No. 6
Comparison of Classification Society Requirements

- 2.5.4 It is concluded that there are large differences between the requirements of the various Classification Societies. This is in contradiction to the assumption by the industry and the Large Yacht Code that 'Class' represents a common standard.
